**REQUEST FOR PROPOSAL
FEDERAL AID BRIDGE DESIGN
TUSCOLA COUNTY
BOARD OF COUNTY ROAD COMMISSIONERS
1733 S. MERTZ RD.
CARO, MI 48723**

1. **VanBuren over Sheboygan I/C Drain Structure 10488**
Denmark Township, Section 29
Replacement Application Estimate: \$715,000

STR 10488

BRIDGE SAFETY INSPECTION REPORT

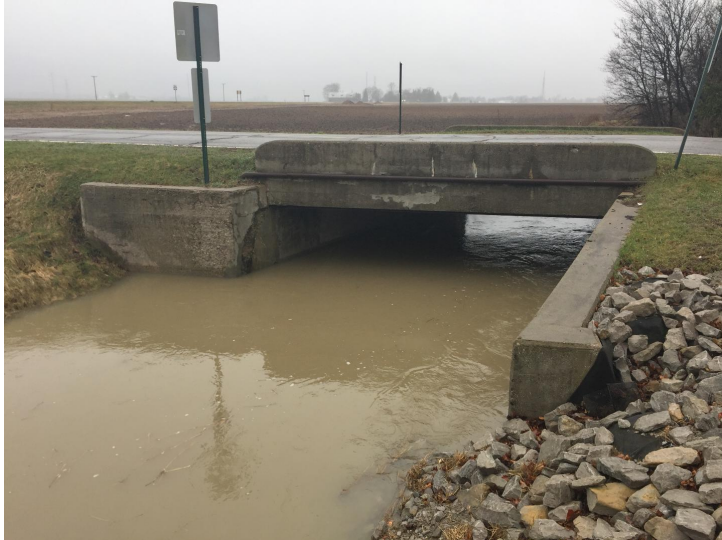
Document Name: IMG_0066.JPG
Category: Elevation
Comments: East elevation

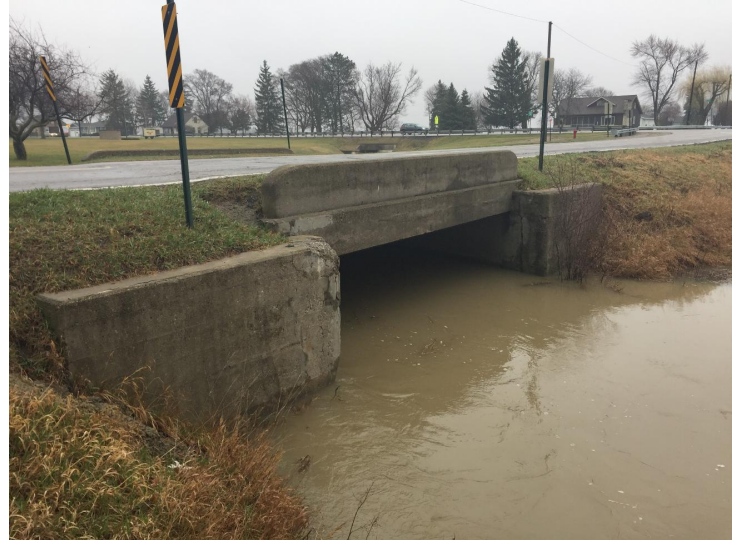
Document Name: IMG_0069.JPG
Category: Elevation
Comments: West elevation

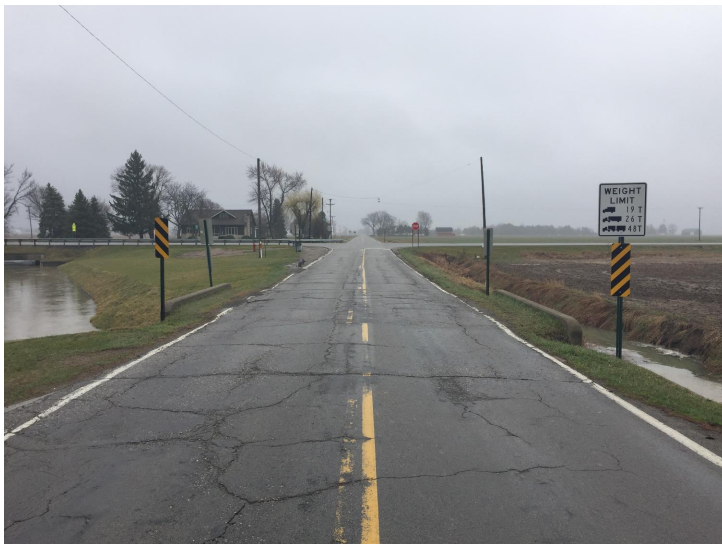
04/15	04/16	04/17	
18. Approach Pavement	5	5	5	HMA approach pavement off each end of the structure. Widespread block cracking spaced 4'-6', some of the open unsealed cracks are up to 1/4" wide. (04/17) HMA approach pavement off each end of the structure. Widespread block cracking spaced 4'-6', some of the open unsealed cracks are up to 1/4" wide. (04/16) HMA approach pavement off each end of the structure. Widespread block cracking spaced 4'-6', some of the open unsealed cracks are up to 1/4" wide. (04/15)

Document Name: IMG_0058.JPG
Category: Approach
Comments: Looking south

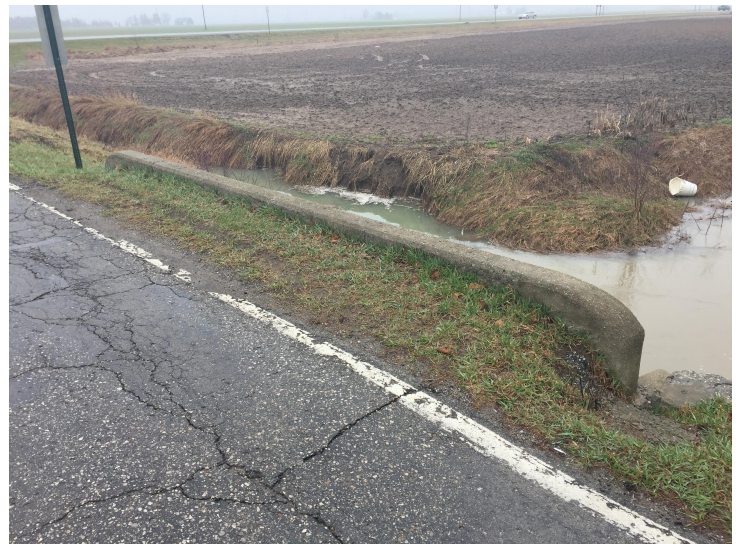
2. Expansion Joints	N	N	N	(04/17) N/A (04/16) (04/15)
3. Other Joints	N	N	N	(04/17) N/A (04/16) (04/15)
4. Railings	5	4	4	Solid concrete barriers. Only approximately 6" of the top of the barrier protrudes above the pavement surface over the structure. No approach guardrail present. The barriers in the present state do not act as railings, but retain road fill over deck. Rating based on low barrier height. (04/17) Solid concrete barriers. Only approximately 6" of the top of the barrier protrudes above the pavement surface over the structure. No approach guardrail present. The barriers in the present state do not act as railings, but retain road fill over deck. Rating based on low barrier height. (04/16) Solid concrete barriers. Only approximately 6" of the top of the barrier protrudes above the pavement surface over the structure. No approach guardrail present. The barriers in the present state do not act as railings, but retain road fill over deck. (04/15)

Document Name: IMG_0060.JPG
Category: Railing
Comments: West railing

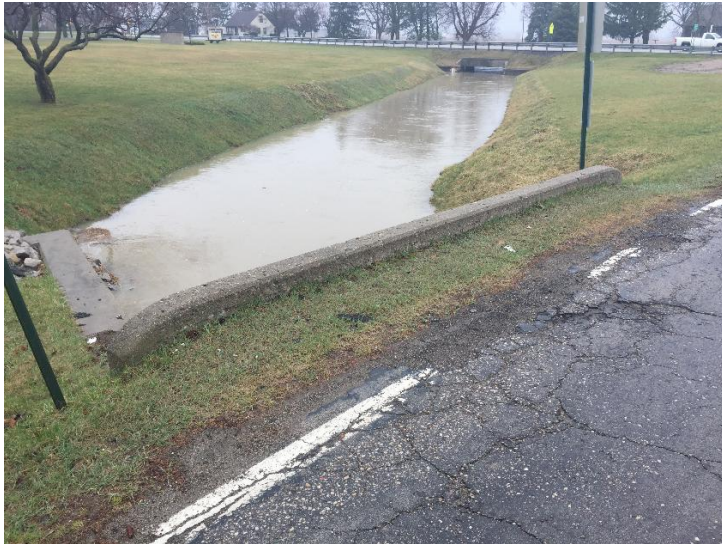
Document Name: IMG_0063.JPG

Comments: East railing

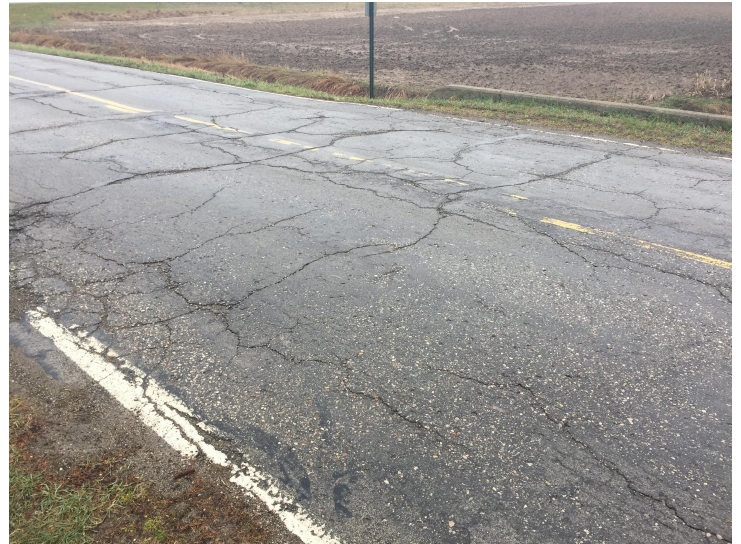
Document Name: IMG_0065.JPG

04/15	04/16	04/17	
1. Surface (SIA-58A)	5	4	4	HMA upper surface with widespread block cracking spaced 1'-2'. Some of the open unsealed cracks are up to 1/4" wide. Road section carried over deck. (04/17) HMA upper surface with widespread block cracking spaced 1'-2'. Some of the open unsealed cracks are up to 1/4" wide. Road section carried over deck. (04/16) HMA upper surface with widespread block cracking spaced 1'-2'. Some of the open unsealed cracks are up to 1/4" wide. Road section carried over deck. (04/15)

Comments: HMA pavement

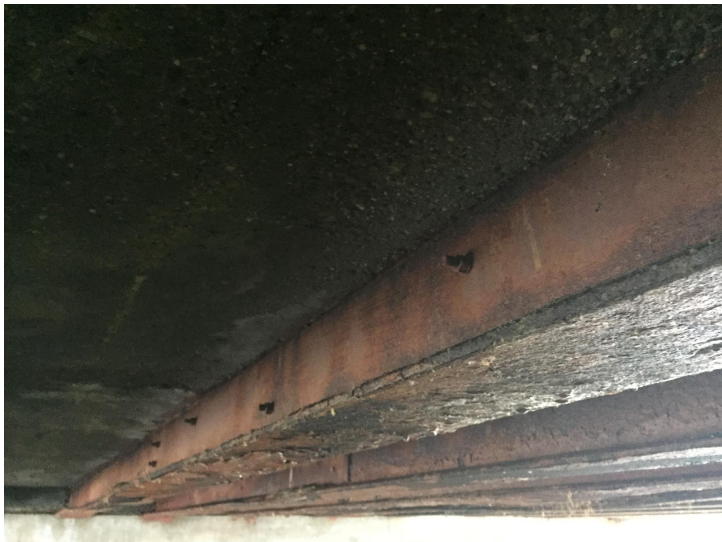
Document Name: IMG_0071.JPG

9. Stringer (SIA-59) 3 3 3 15 painted steel I-beams with full length cover plates. Fascia beams are encased in concrete up to 90% of their overall height. Interior beams are encased in concrete up to 75% of their overall height. Welded cover plates along bottom flanges have separated from beams 6w, 8w, 9w, 10w, 11w and provide zero capacity. Beam 6w has heavy scale along entire length with a 2" diameter hole through the web, 4' from south abutment. Beam 13w has a 8"x6" hole through the web at the south abutment. Beam 14w has a 9"x2" long hole through the web at the south abutment. (04/17)

10. Paint (SIA-59A) 2 2 2 Approximately 95% of the paint system has failed. (04/17)
 Approximately 95% of the paint system has failed. (04/16)
 100% paint failure on the steel I-beams. (04/15)

Comments: Typical beam

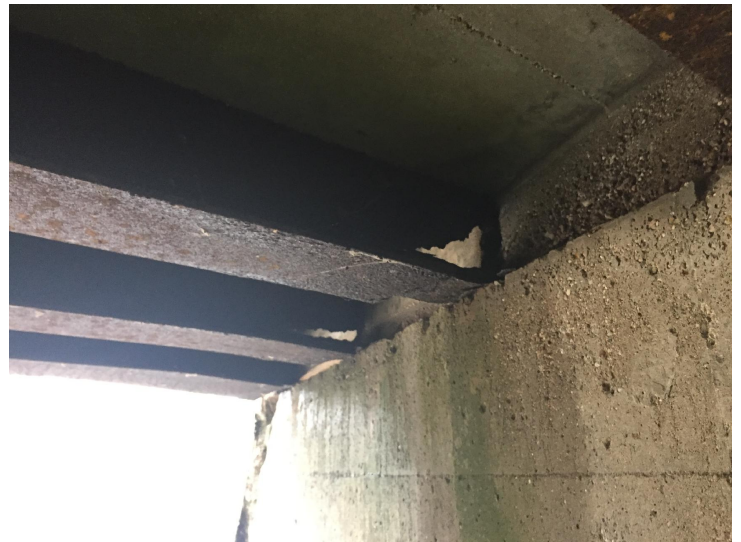
Document Name: IMG_0072.JPG

11. Section Loss 0 0 0 Holes near south abutment in beam 6w (2"x2"), beam 13w (8"x6"), and beam 14w (9"x2"). (04/17)
 Beam 6w has heavy scale along entire length with a 2" diameter hole through the web, 4' from south abutment. Beam 13w has a 7"x4" hole through the web at the south abutment. Beam 14w has a 9" long hole through the web at the south abutment. (04/16)
 Holes through 3 beams (04/15)

Comments: Holes in beams 13w and 14w at south abutment

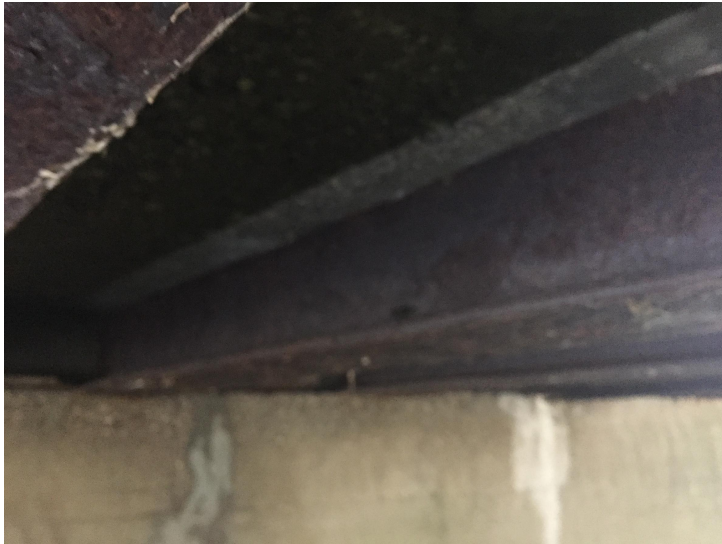
Document Name: IMG_0079.JPG
Category: Superstructure
Comments: Hole in web of beam 6w near south abutment

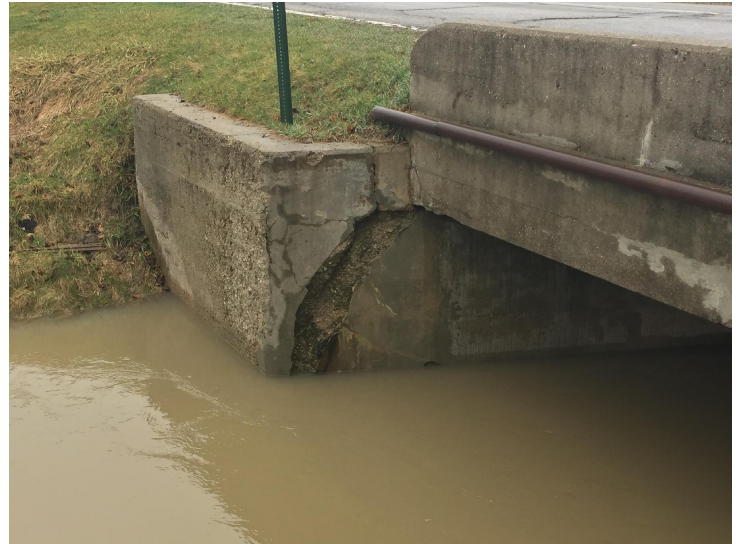
13. Abutments (SIA-60)	4	4	4	Concrete cantilever abutment walls. The main walls under the structure are in overall fair condition. All four corners of the concrete return walls are scaled, with delaminations and surface spalls, the northwest corner is spalled up to 9" deep, the southwest and southeast corners are spalled up to 6" deep. North abutment footing is exposed as follows: Beam 1w - 0", 3w - 1", 8w - 2". (04/17) Concrete cantilever abutment walls. The main walls under the structure are in overall fair condition. All four corners of the concrete return walls are scaled, with delaminations and surface spalls, the northwest corner is spalled up to 9" deep, the southwest and southeast corners are spalled up to 6" deep. North abutment has a 2'x2' spall near the center. North abutment footing is exposed as follows: Beam 1w - 0", 3w - 1", 5w - 8", 8w - 0". (04/16) Concrete full height abutment walls. The main walls under the structure are in overall fair condition. All four corners of the concrete return walls are scaled, with delaminations and surface spalls, the northwest corner is spalled up to 9" deep, the southwest and southeast corners are spalled up to 6" deep. North abutment has a 2'x2' spall near the center. North abutment footing face exposed as follows: Beam 1W - 0", 3W - 1", 5W - 8", 8W - 0". (04/15)

Document Name: IMG_0068.JPG
Category: Substructure
Comments: South abutment, east end

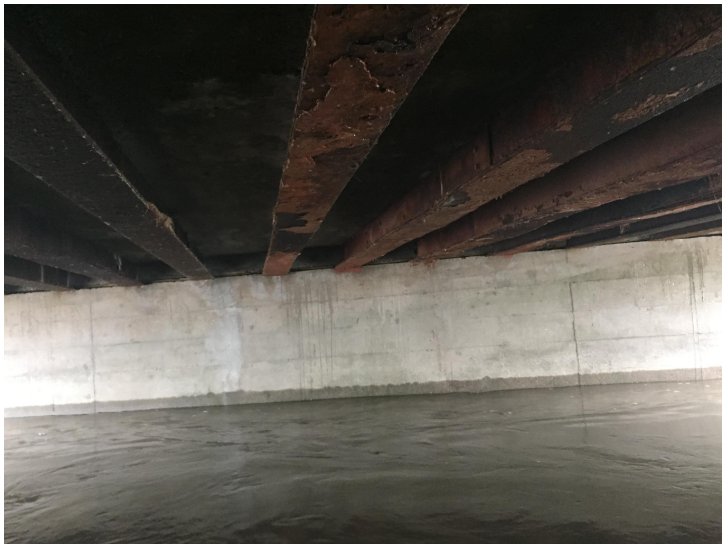
17. Scour Inspection		4	4	Probed, north abutment footing is exposed, not undermined. North abutment footing is exposed as follows: Beam 1w - 0", 3w - 1", 8w - 2". (04/17) Probed, north abutment footing is exposed, not undermined. North abutment footing is exposed as follows: Beam 1w - 0", 3w - 1", 5w - 8", 8w - 0". (04/16) (04/15)

Document Name: IMG_0070.JPG
Category: Substructure
Comments: North abutment

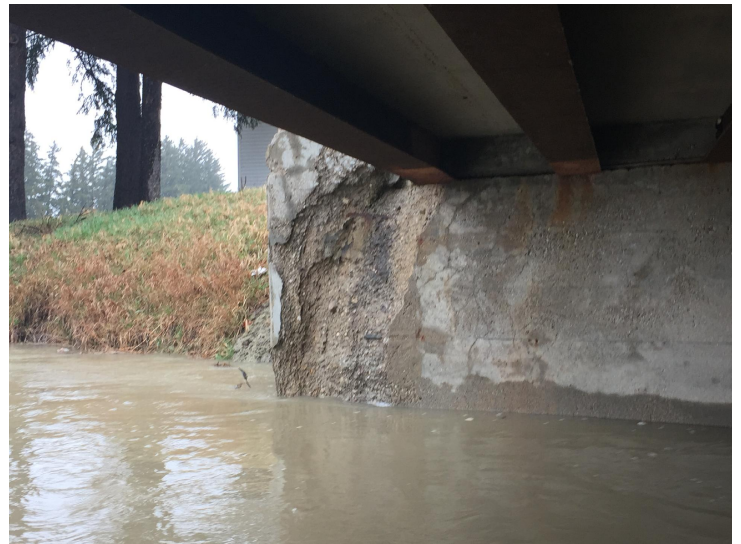
Document Name: IMG_0075.JPG
Category: Substructure
Comments: North abutment, west end

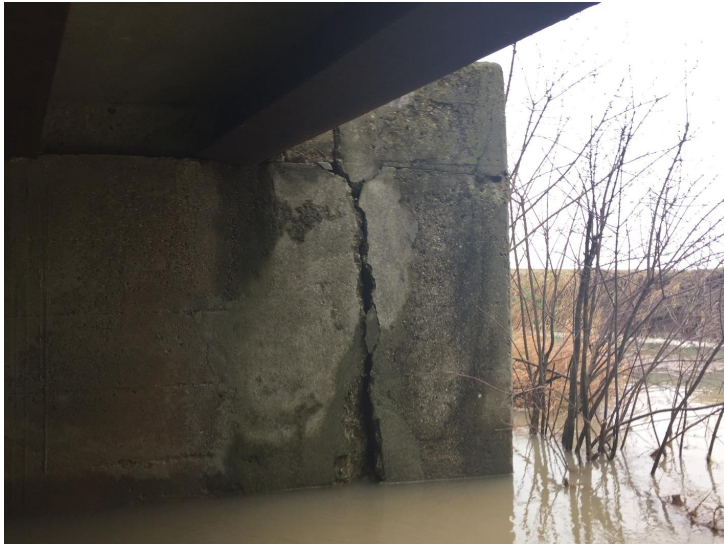
Document Name: IMG_0077.JPG
Category: Substructure
Comments: South abutment, west end

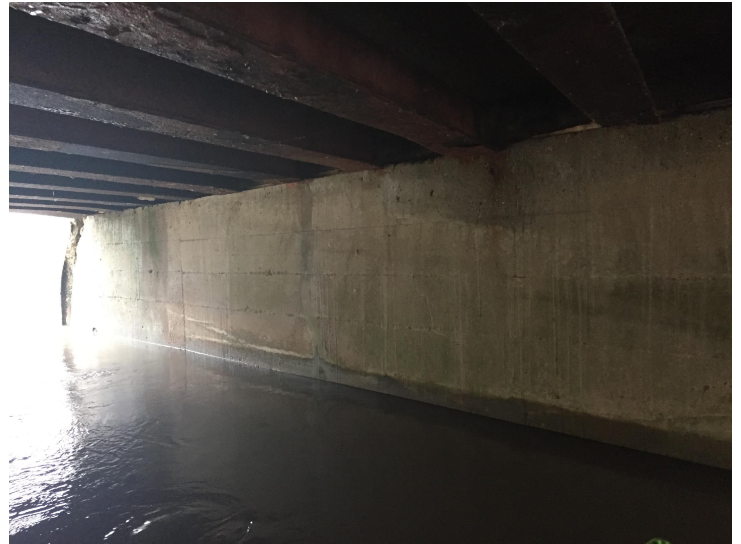
Document Name: IMG_0080.JPG
Category: Substructure
Comments: South abutment

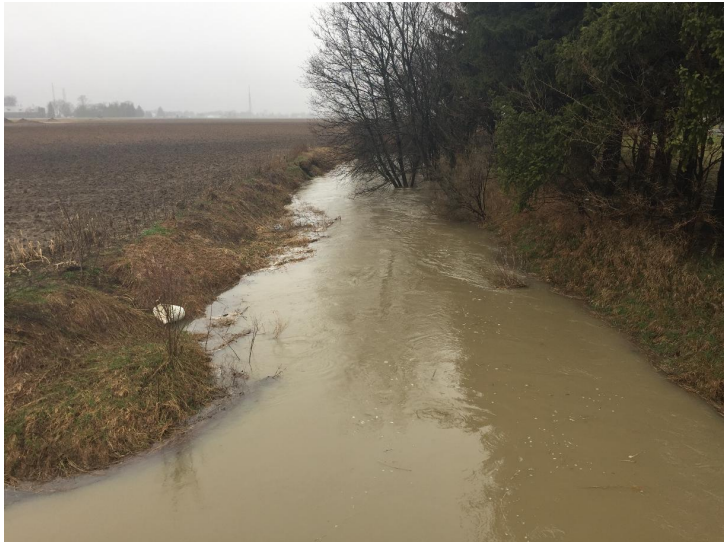
14. Piers (SIA-60)	N	N	N	(04/17) N/A (04/16) (04/15)
15. Slope Protection	N	N	N	(04/17) None present. (04/16) (04/15)
16. Channel (SIA-61)	7	7	7	Water flows up against each abutment wall. Banks are stable, sandy channel bottom. (04/17) Water flows up against each abutment wall. Banks are stable, sandy channel bottom. (04/16) Water flows up against each abutment wall. Banks are stable, sandy channel bottom. (04/15)

Document Name: IMG_0061.JPG
Category: Channel
Comments: West channel

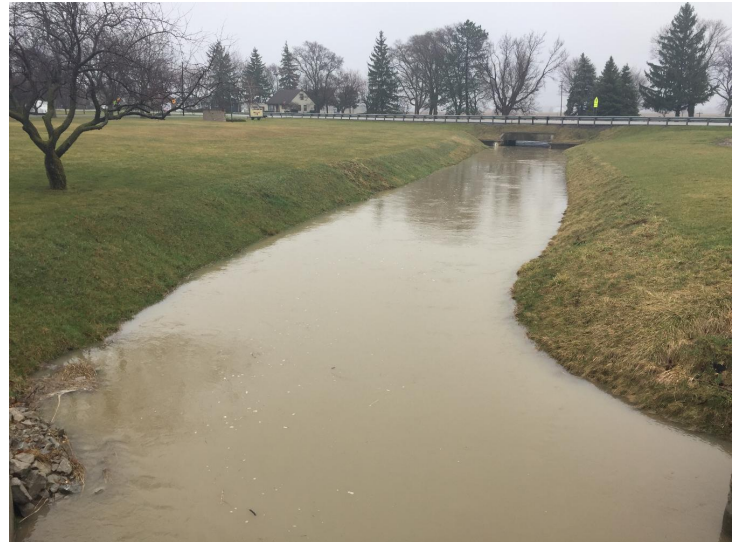
Document Name: IMG_0064.JPG
Category: Channel
Comments: East channel
